CH-47 ACCIDENT SUMMARY

1 July 1966 through 30 June 1967

by
P. R. Thompson

Education and Literature Division

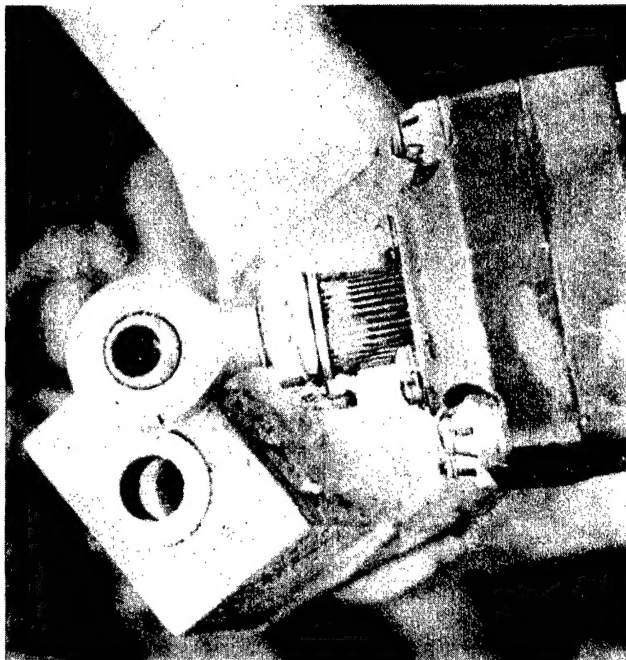
011506—Aircraft disintegrated in air. Six crew-

members and three passengers killed. Caused by fatigue failure of spar of one aft rotor blade at station 200.5.

011506-Fatigue failure of aft rotor blade spar caused aircraft to disintegrate during flight.

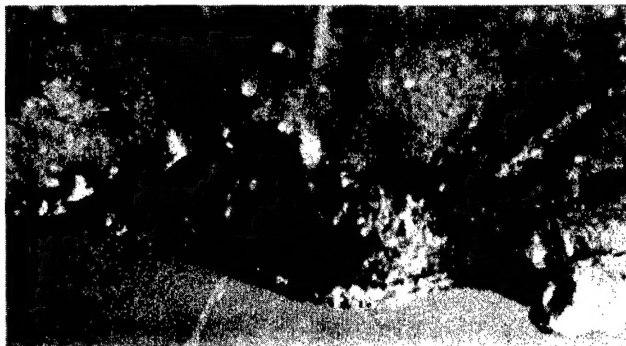
H225—Aircraft disintegrated at about 3,000 feet, separating into two flaming parts before striking ground. All five crewmembers killed. Caused by failure to safety upper nut on pin attaching aft speed trim actuator to swashplate and by improper technical inspection of aft speed trim actuator after removal and installation. The loss of upper longitudinal speed trim actuator bolt from aft rotor swashplate attaching lug caused aft swashplate, controlling aft rotor blades, to become unstable. This caused extreme flapping of aft rotor blades, allowing blades to strike fuselage and break off. Unbalance of rotor head caused aft pylon to separate in flight.

H225-Loss of upper longitudinal speed trim actuator bolt from aft rotor swashplate attaching lug caused by failure to safety upper nut on pin.
